Report of Turnover Study

RICHMOND PARK I CONDOMINIUM ASSOCIATION

**2311, 2318, 2326, 2335, 2327 Sawyers Hill Road,
2343, 2344 Sheen Lane,
Naples, Collier County, Florida**

**SOCOTEC Project Number 6671-001.01
July 2022**

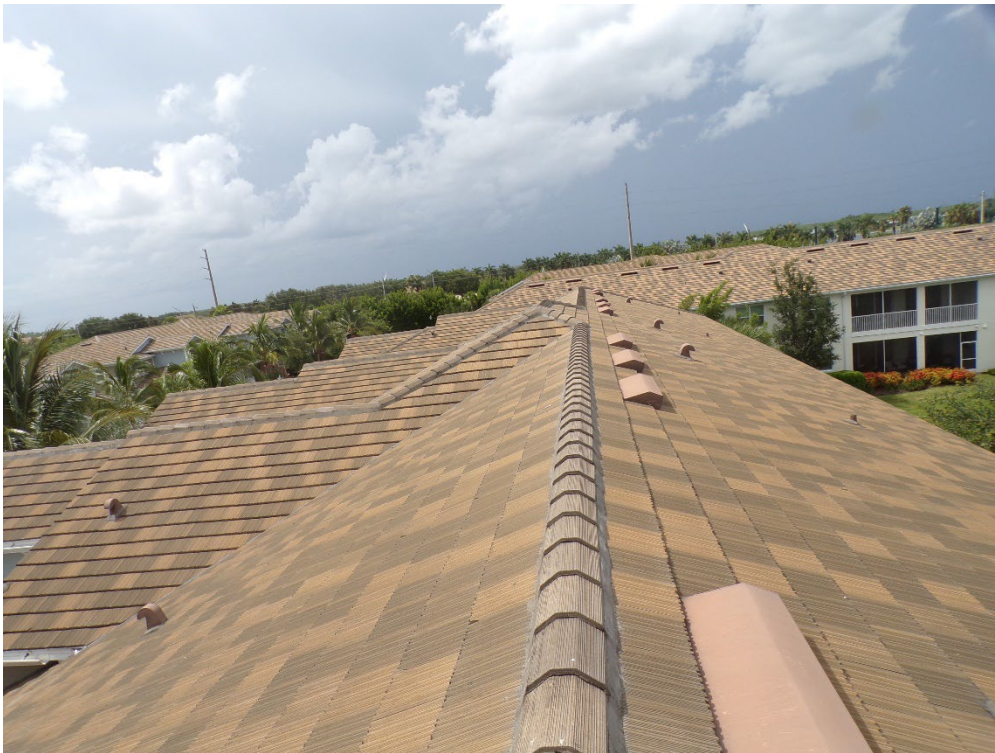
Overall view of typical roof.

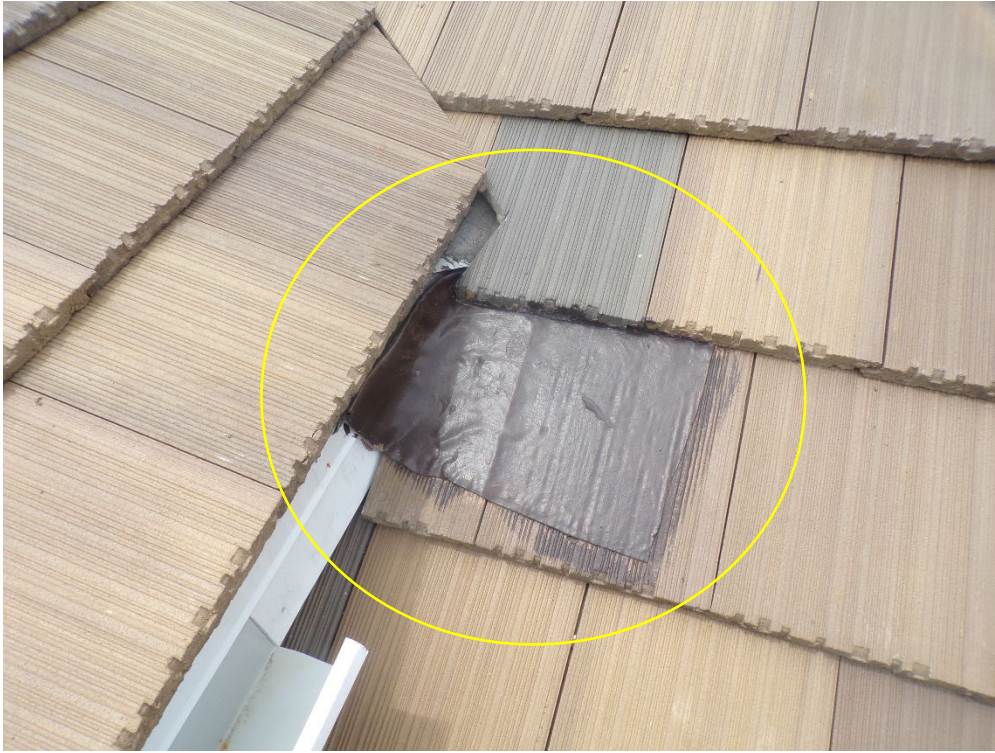
- Between 15 and 20 cracked or shattered roof tiles per each roof inspected.
- Construction debris observed on each roof inspected.
- Uncompleted flashing work on each roof observed.

View of incomplete flashing metal installation.

Condominium Buildings: 7 Amenity Buildings: 0			Building CO'd: 2017 - 2022		
ELEMENT	ELEMENT CONDITION	Required Maintenance Costs	Estimated Useful Life (years)	Approximate Remaining Useful Life (years)	Estimated Replacement Cost
ROOFS	Fair	\$21,000	25	23-25	\$862,500
Address incomplete flashing work on roofs, buildings 2318, 2326		\$8,000			
Address reported roof leaks, buildings 2281, 2295		\$10,000			
Address cracked/shattered roof tiles, all roofs.		\$2,500			
Address miscellaneous debris on roofs, buildings 2318, 2326		minimum			
STRUCTURES	Good to Fair	\$3,000	40+ (Buildings)	40+	NA
Address concrete cracking in unit entryway, building 2327.		\$3,000			
FIRE PROTECTION SYSTEMS	Good to Fair	\$500	25+ (Fire Sprinkler System) 25 (Fire Sealant)	23-25	\$140,000
Address expired FACP inspection, building 2318, 2326, 2343		minimum			
HEATING AND COOLING	Good	\$0	12 (HVAC Systems)	9-12	NA
PLUMBING	Good	\$0	40+ (Water/Sewer Lines)	39+	NA

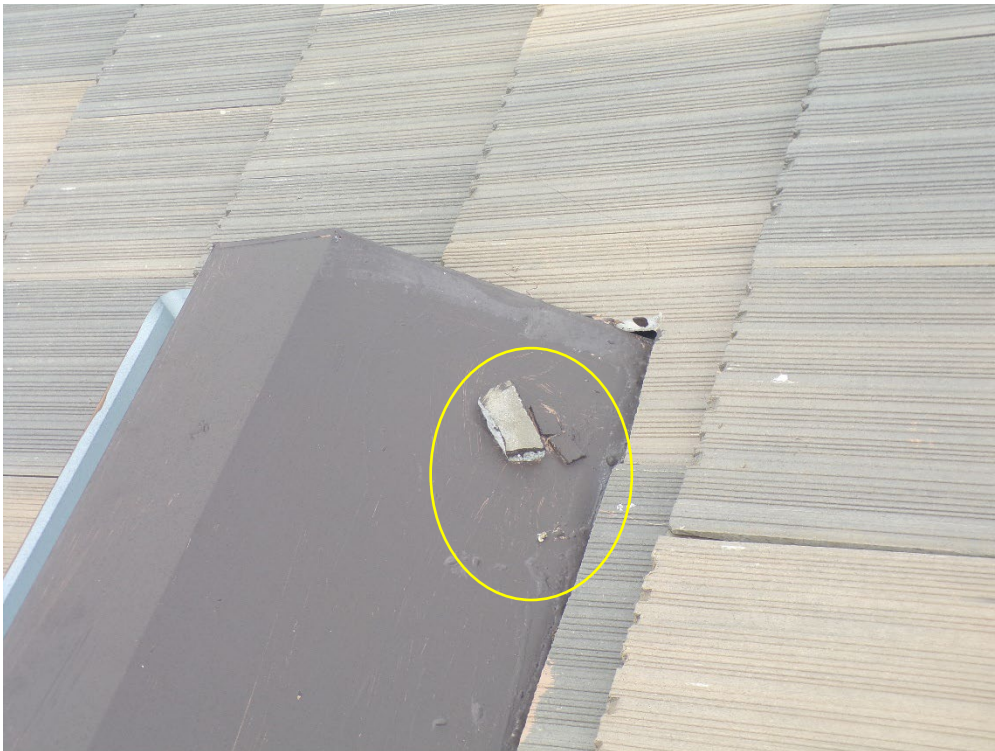
View of debris left behind on roof.

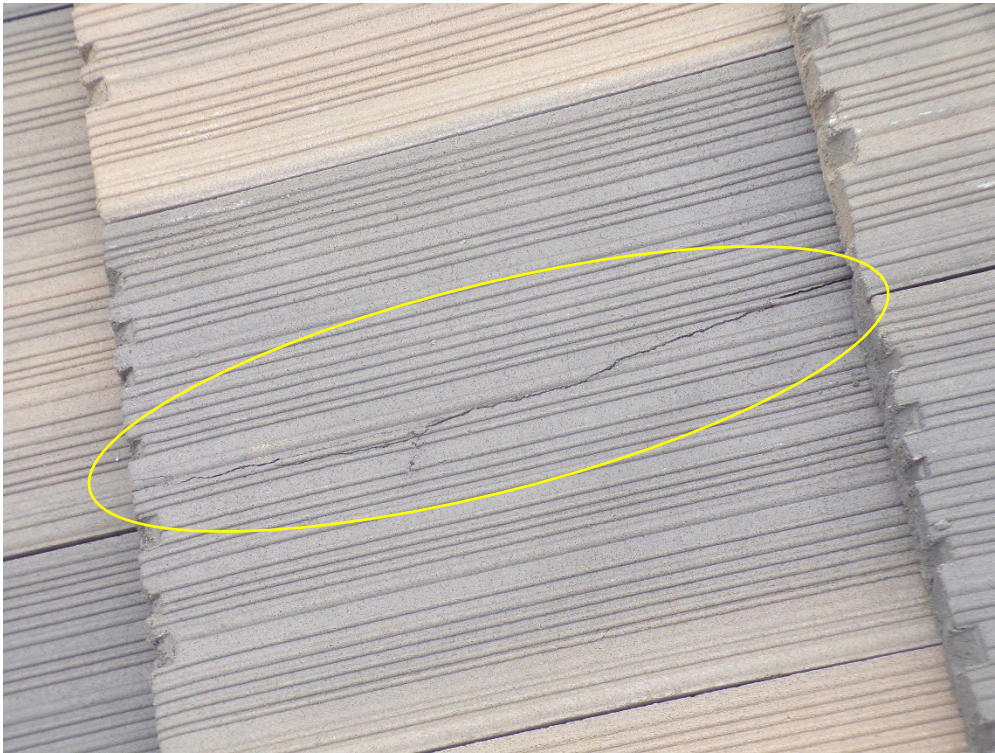
View of shattered roof tile.

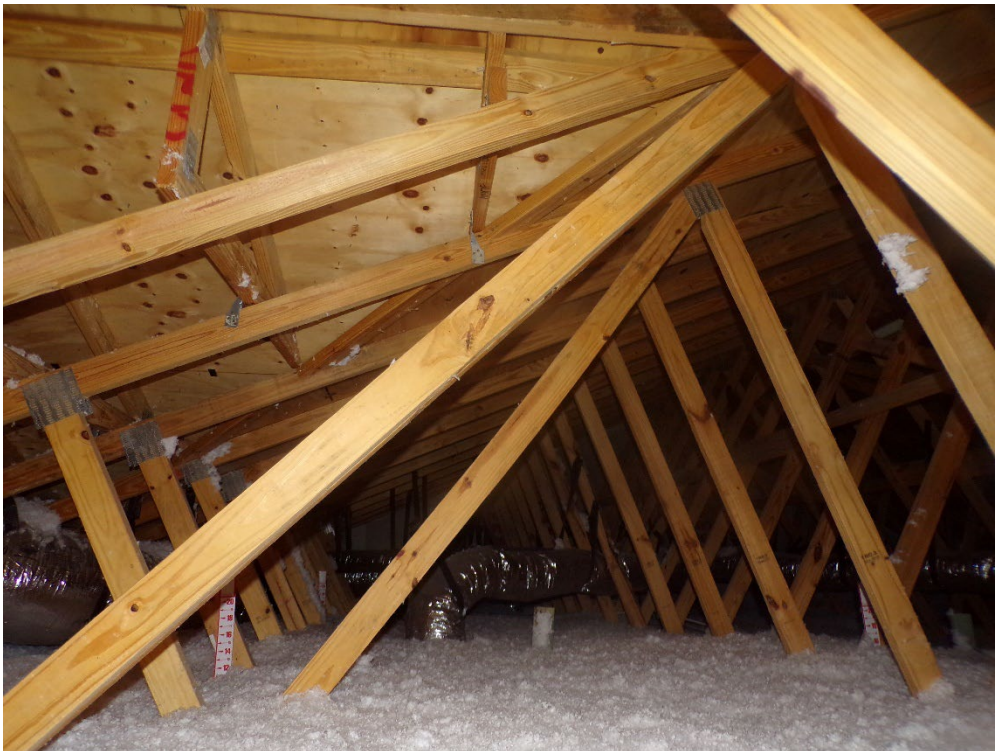
The attics were observed to be in overall good condition at the time of our visit.

Overall view of typical attic.

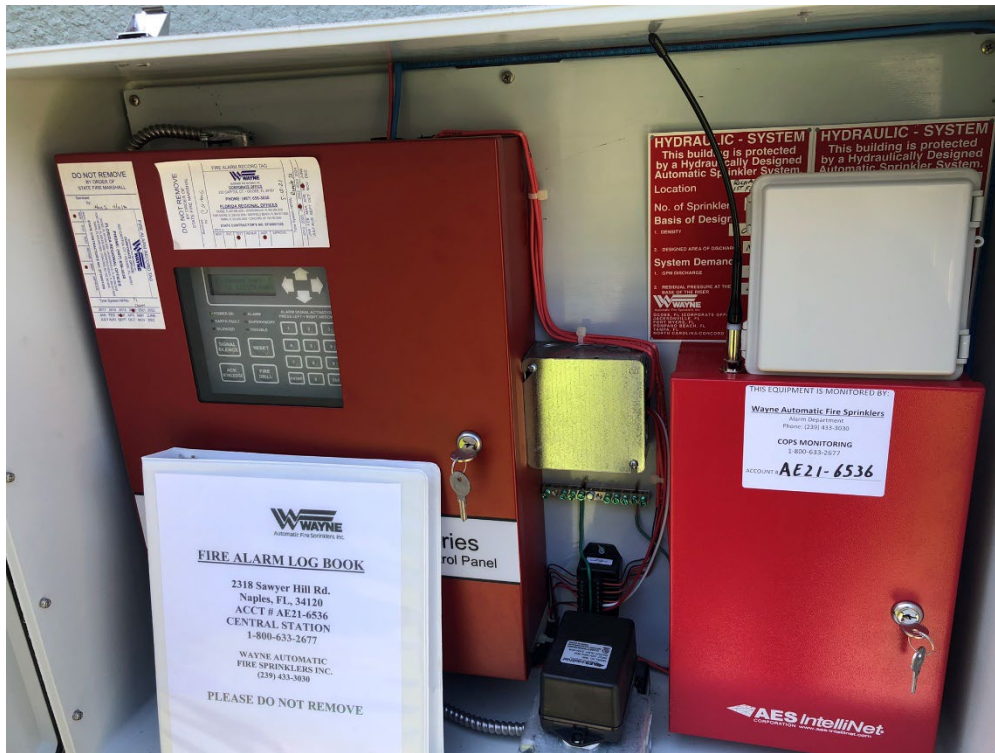
- Expired inspection dates for FACP controls, buildings 2318, 2326, and 2343.

View of typical FACP controller, with expired inspection tag.

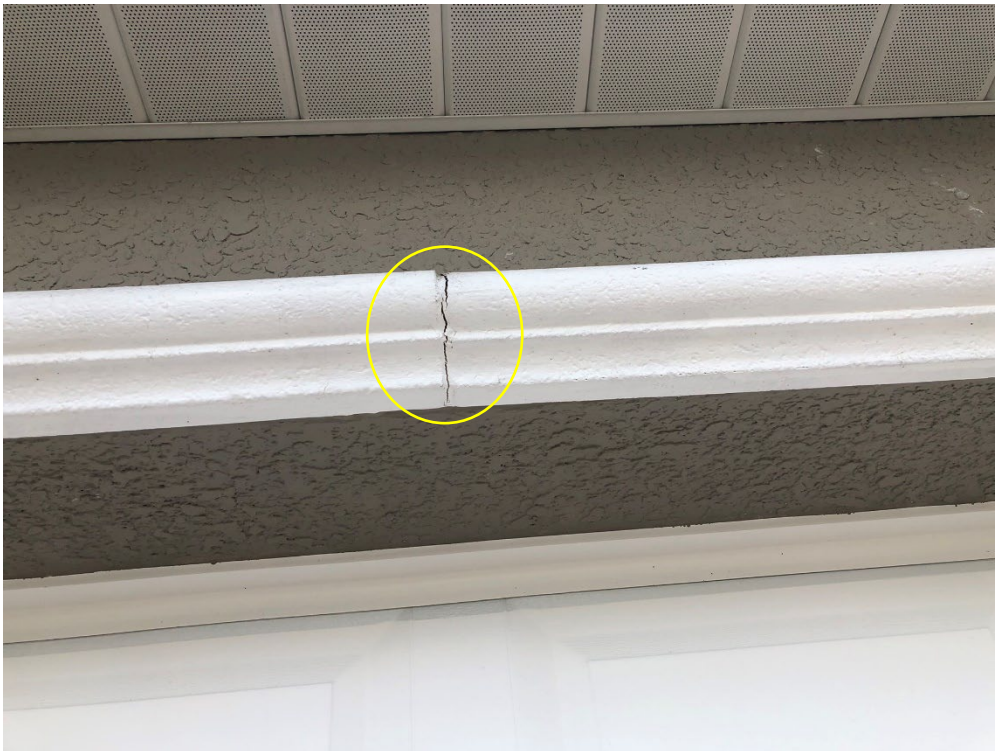
- Cracked and/or damaged stucco observed at all buildings.
- Areas of unpainted stucco, stained paint, and/or paint dripping observed at all buildings.
- Damaged decorative banding on buildings 2326 and 2344

View of damaged decorative banding.

ELECTRICAL SYSTEMS	Good	\$0	25+ Exterior Light Fixtures	23+	NA
PAVEMENT AND PARKING AREAS	Good	\$0	40+ (Concrete Pavers)	38+	\$186,000
DRAINAGE SYSTEMS	Good	\$0	30+ (Drainage Lines)	28+	NA
PAINTING	Fair	\$21,500	Paint 6 (Increase useful life to 7 years after first recoat)	4-6	\$120,750
Address Damaged/cracked stucco, all buildings.		\$14,000			
Address paint drip, all buildings.		\$4,000			
Address unpainted surfaces, buildings 2318, 2326, 2327,		minimum			
Address damaged EFIS trim, buildings 2326, 2344,		\$3,000			
ELEMENT TOTAL		\$46,000			
Required Maintenance Costs include permit fees, construction overhead and taxes but exclude special equipment needed to access an element's location.					
Minimum = Approximate minimum fee to complete a required maintenance item.					
Estimated Useful Life assumes that all maintenance is done correctly and in a timely manner.					
Estimated Required Maintenance Costs for each category are the sum of the estimated repair costs for each item identified within the Turnover portion of the report.

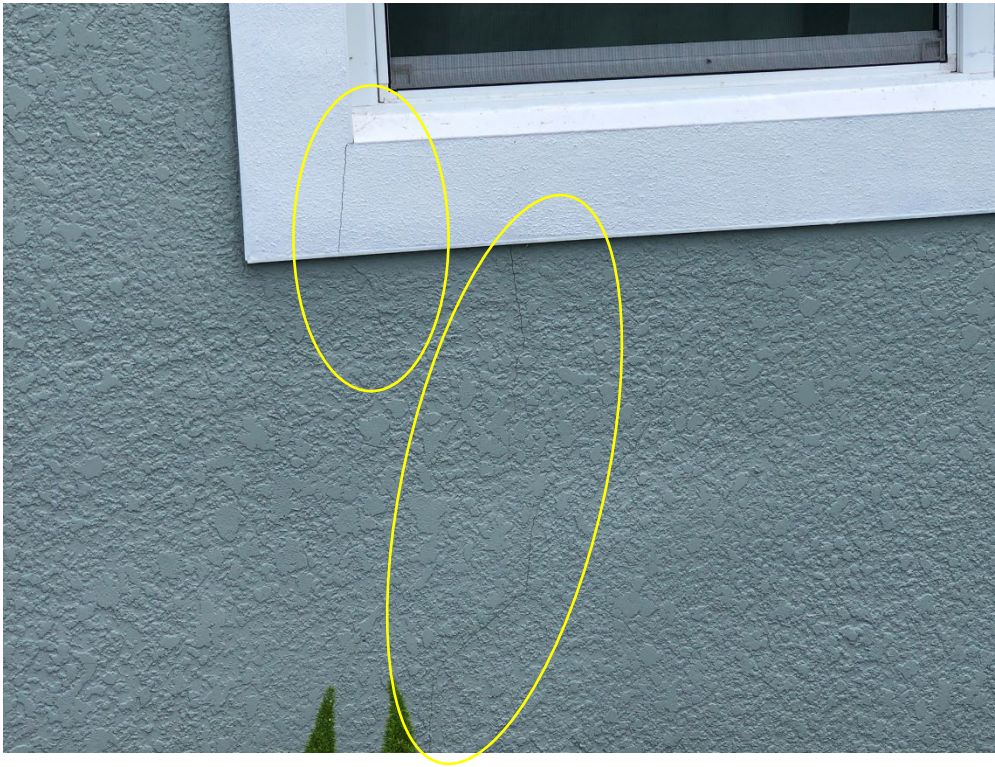
View of typical stucco cracking.

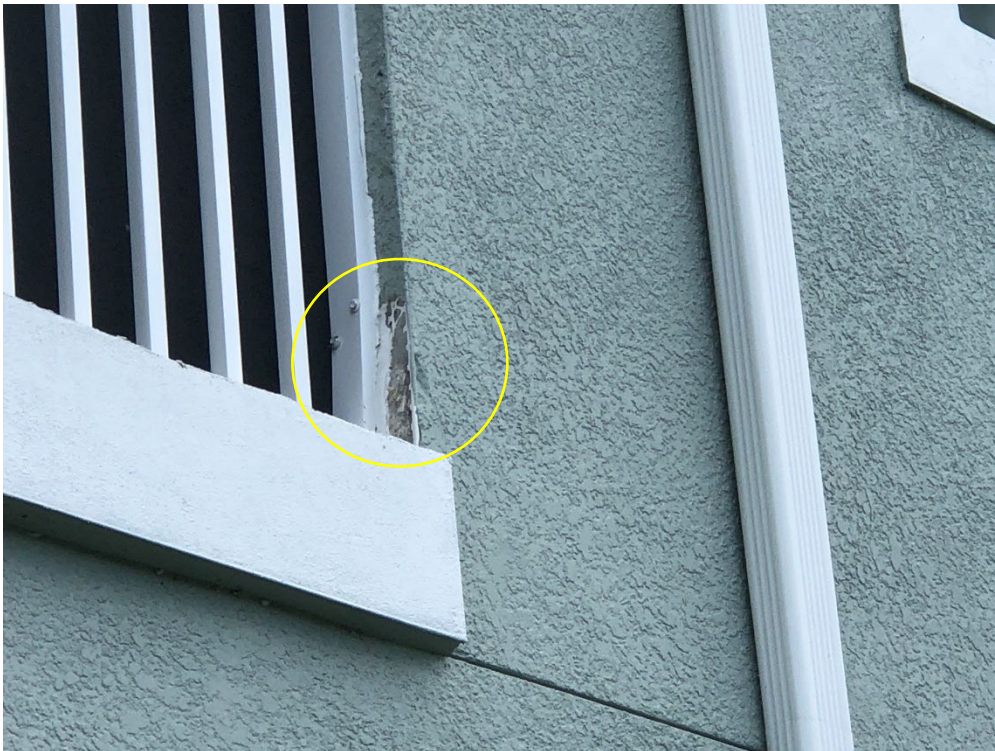
View of damaged stucco on building 2327.

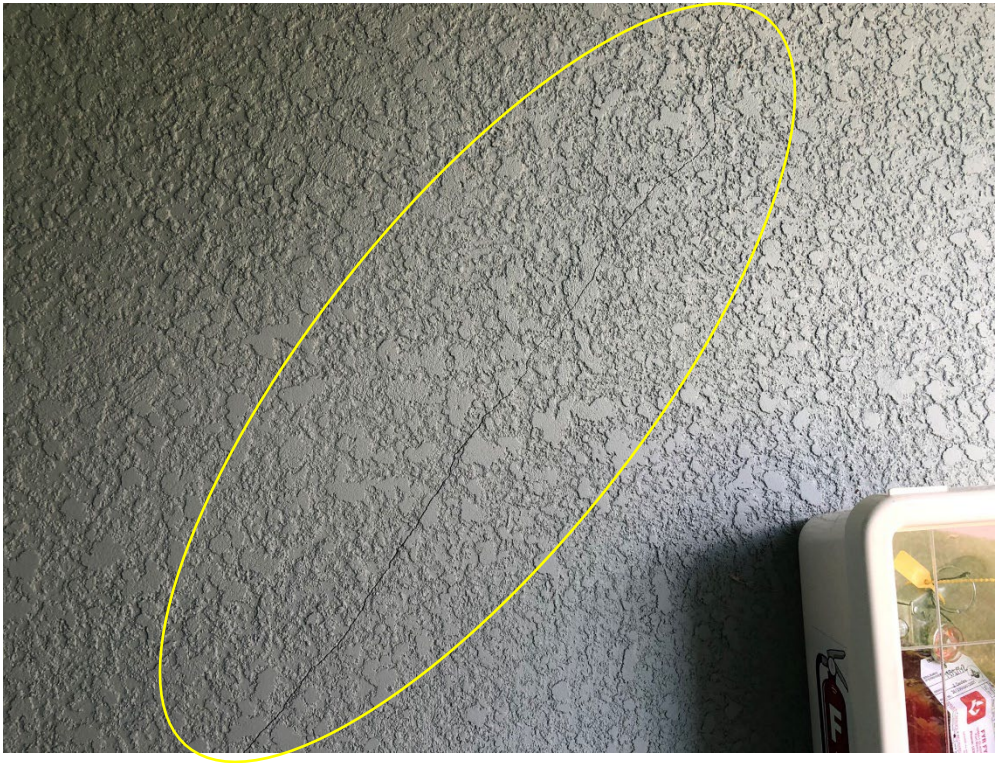
- At least one instance of stucco cracking observed outside a unit entrance in building 2327.

View of stucco cracking in unit entryway, building 2327.

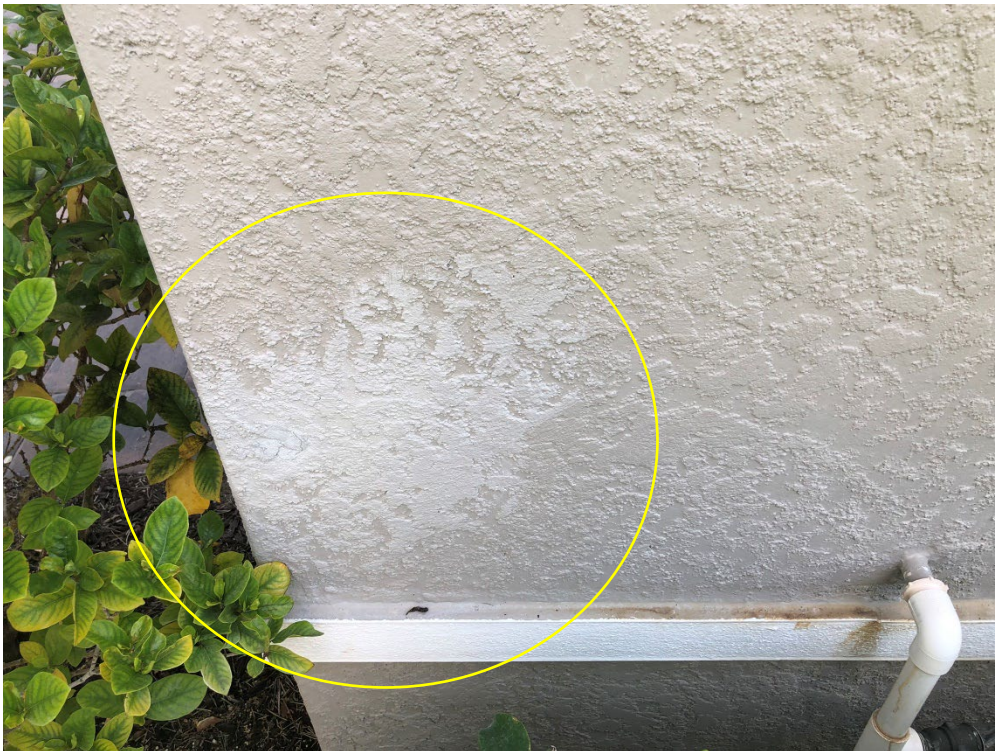
View of unpainted stucco, building 2326.

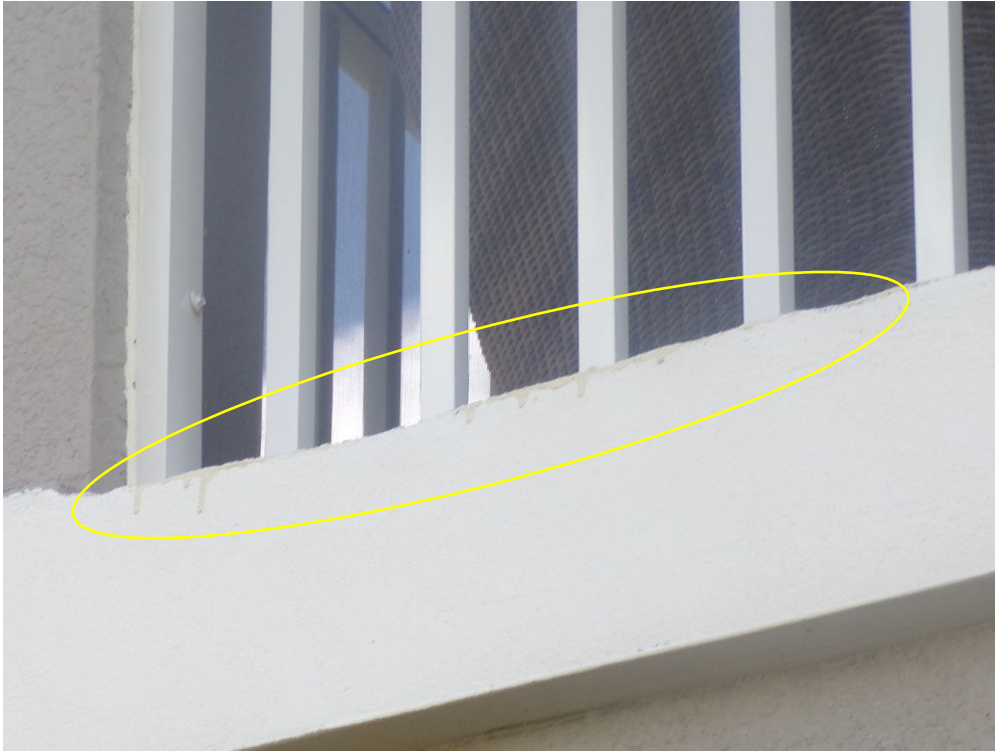
View of typical paint dripping.
