Report of Turnover Study

RICHMOND PARK II CONDOMINIUM ASSOCIATION

**SOCOTEC Project Number 6732-001.01
July 2022**

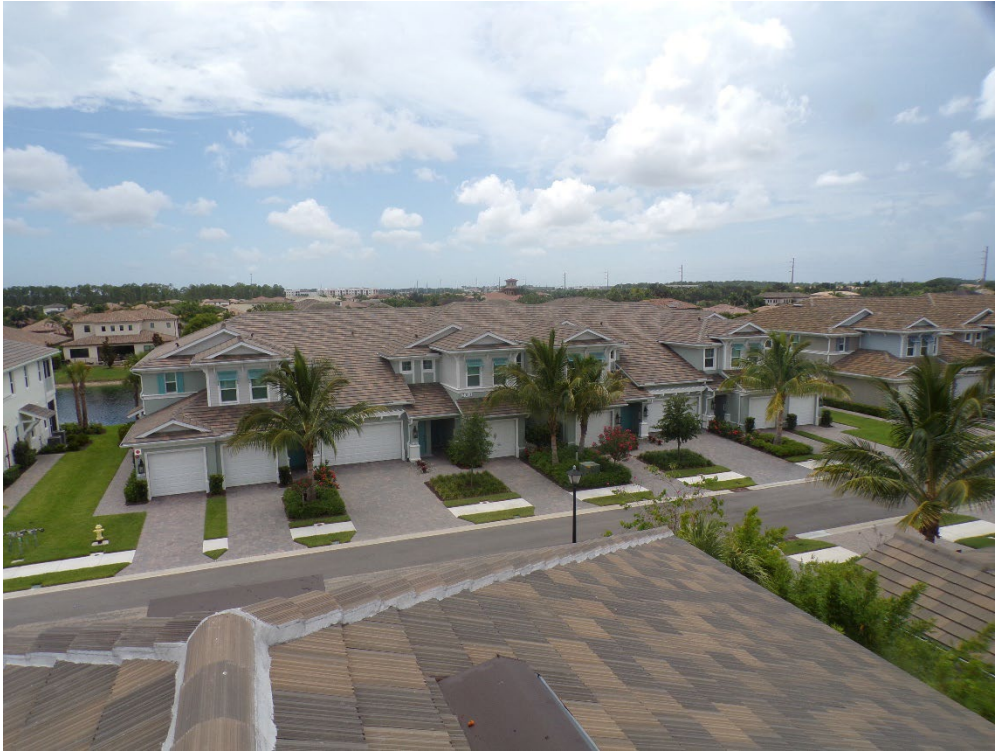
View of typical Richmond Park building.

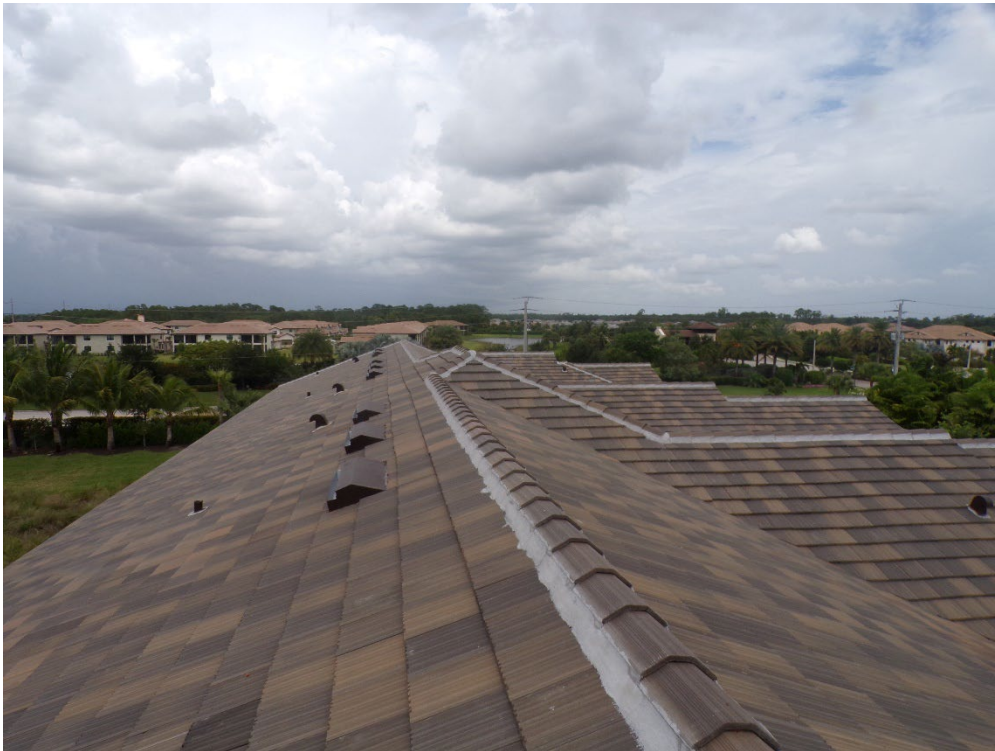
The roofs were observed to be in fair overall condition at the time of our site visit.

- Between 15 and 20 cracked or shattered roof tiles per each roof inspected.
- Construction debris observed on each roof inspected.
- Reported roof leaks on buildings 2281 and 2295.

Overall view of typical roof.

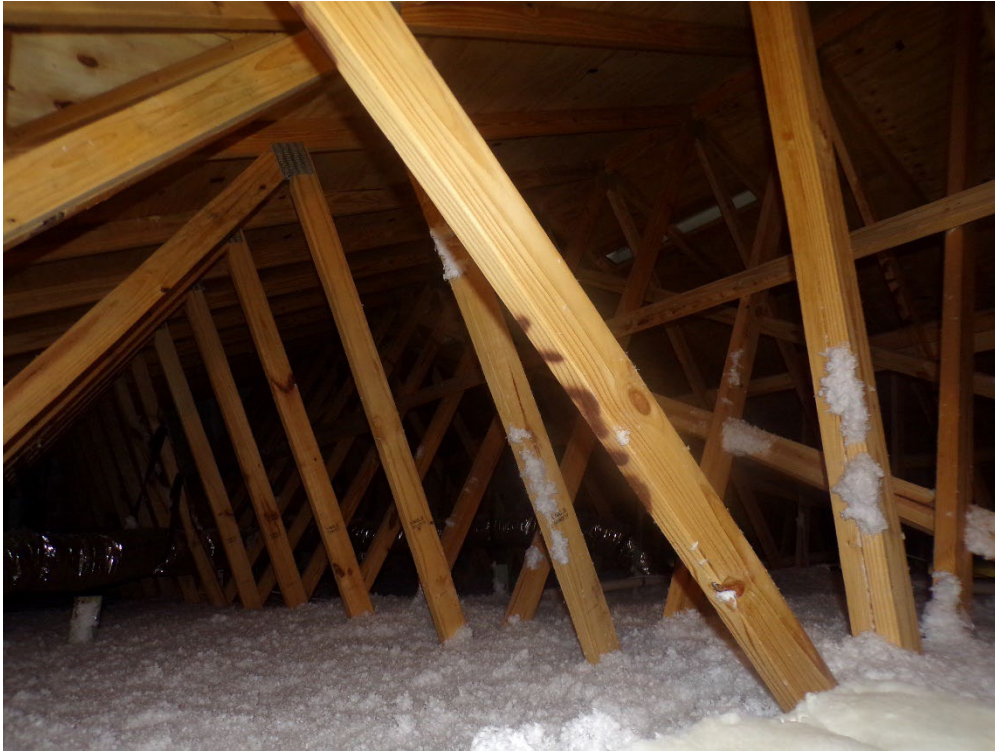
The attics were observed to be in overall good condition at the time of our visit.

Overall view of typical attic.

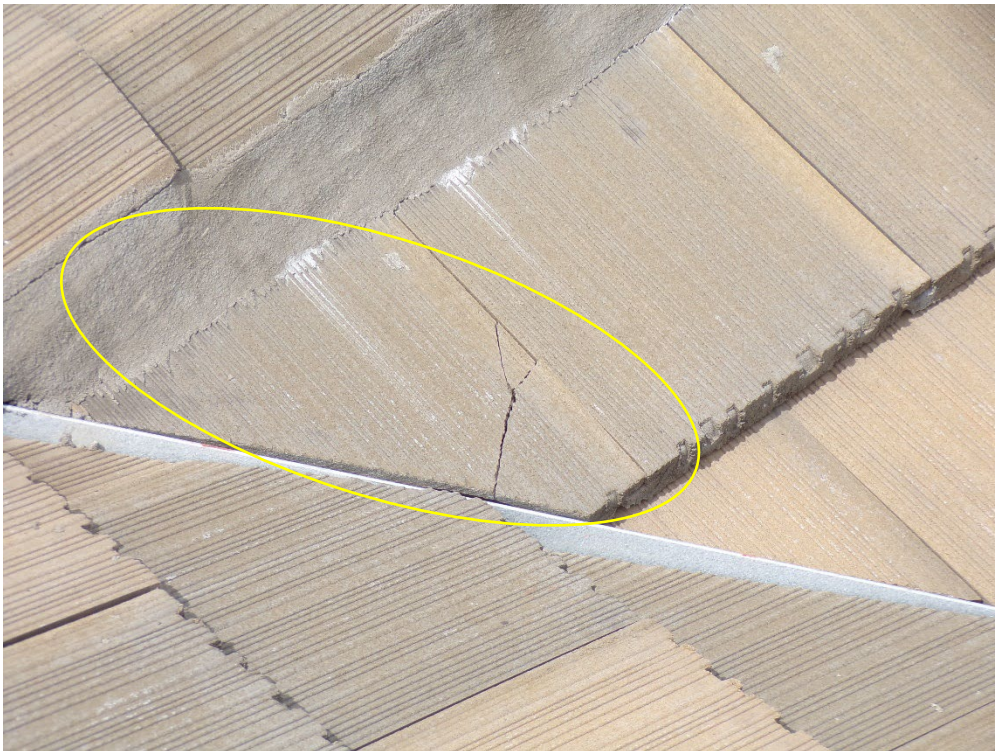
View of typical shattered roof tile.

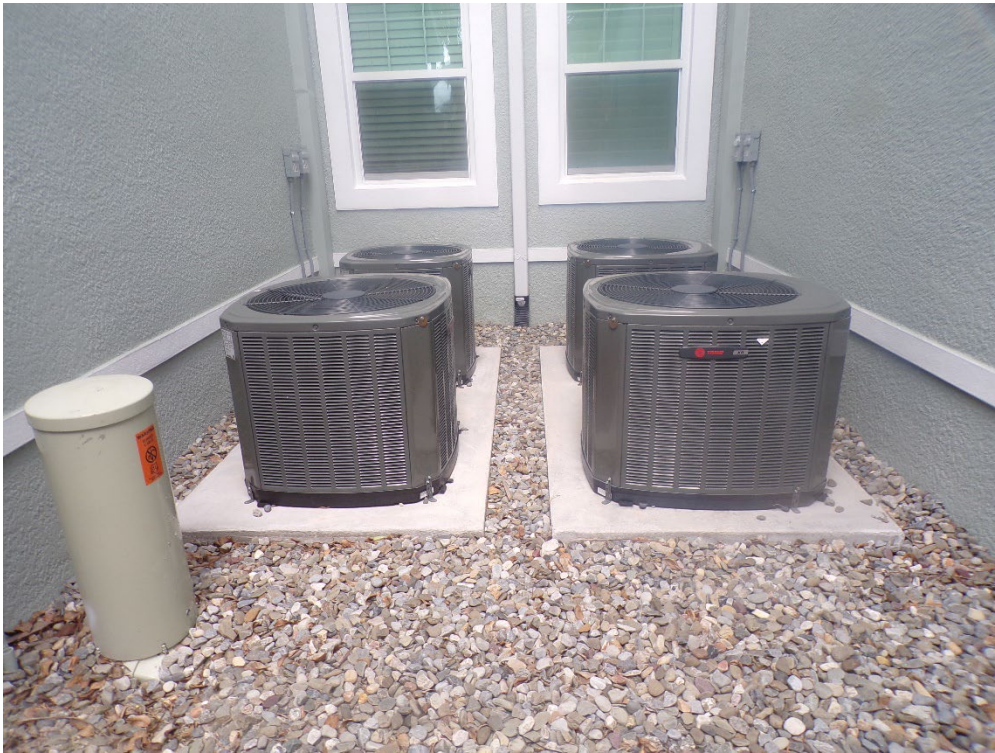
View of typical HVAC setup.

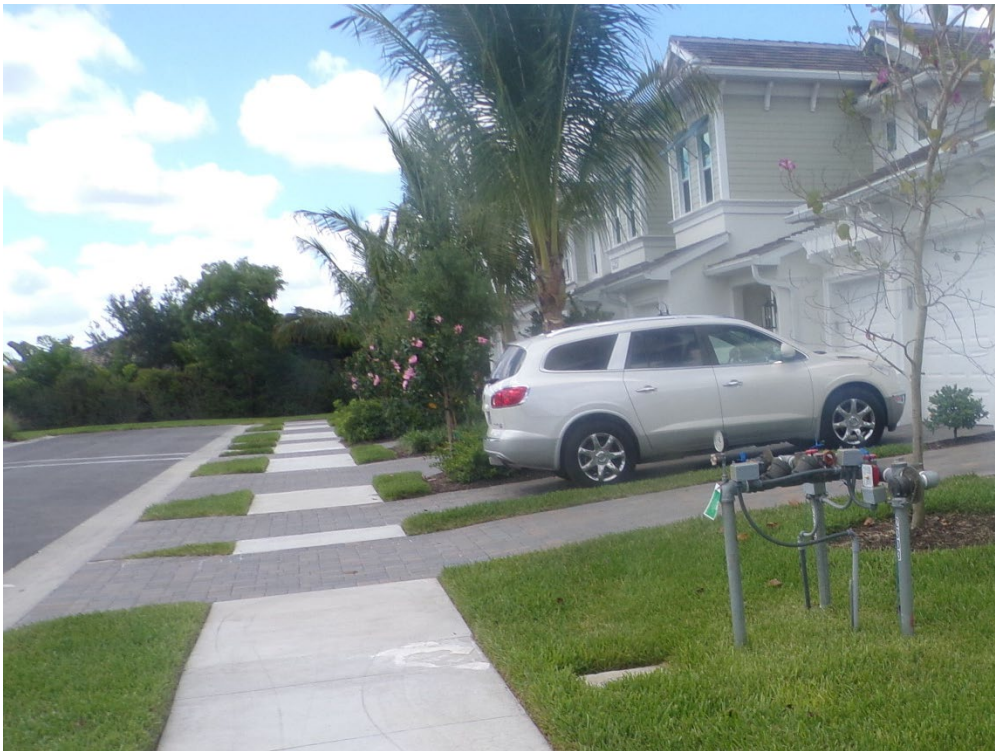
We understand that the roadways and common parking areas located throughout Richmond Park II are maintained by the Master Association. However, Richmond Park II maintains the interlocking concrete paver driveways, and unit walkways. In general, these items were observed to be in good to fair overall condition at the time of our site visit.

- Settling pavers were observed in unit 702's driveway, outside building 2319.

Overall view of typical paver driveways.

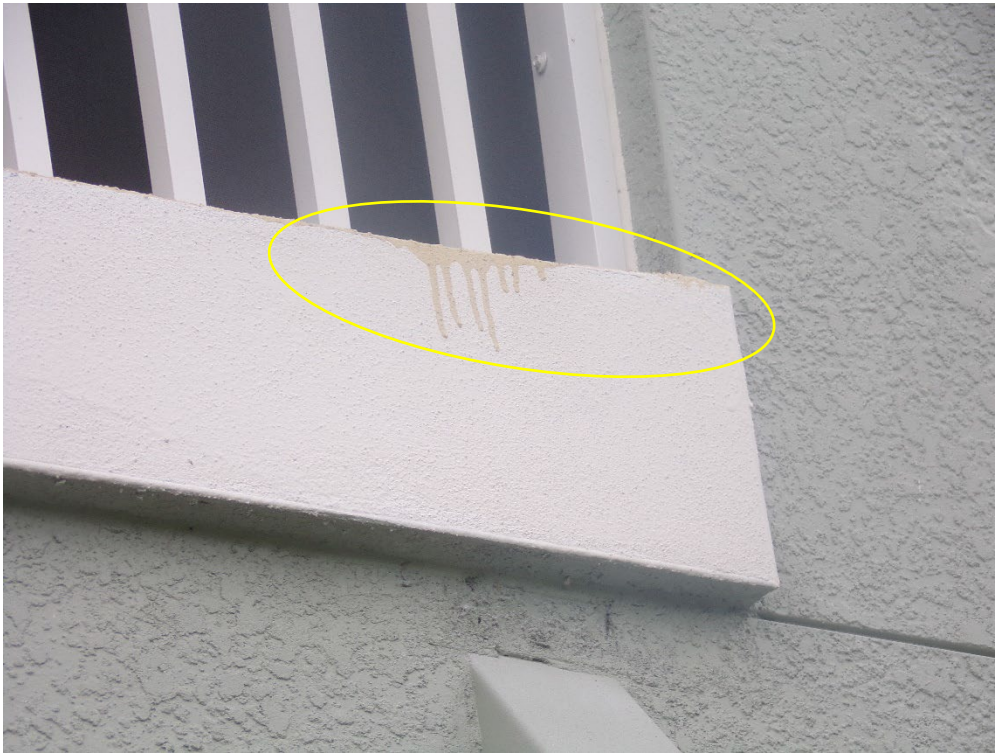
- Cracked and/or damaged stucco observed at all buildings.
- Areas of unpainted stucco, stained paint, and/or paint dripping observed at all buildings.
- Damaged decorative banding trim on buildings 2295 and 2319.

View of typical paint drippage.

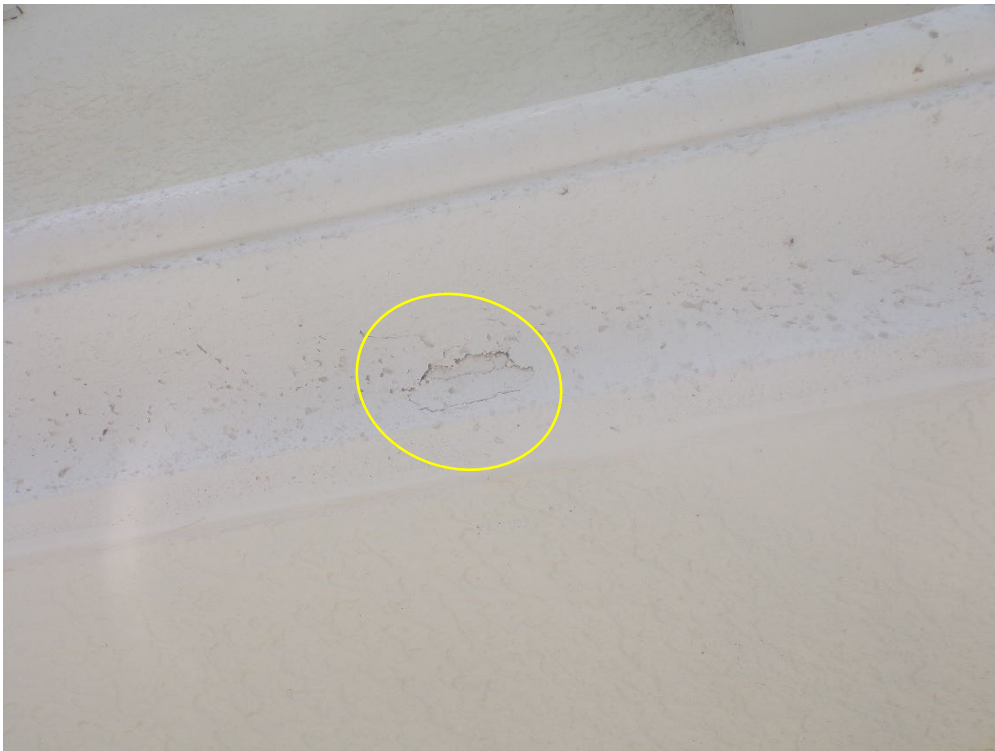
View of typical decorative banding.

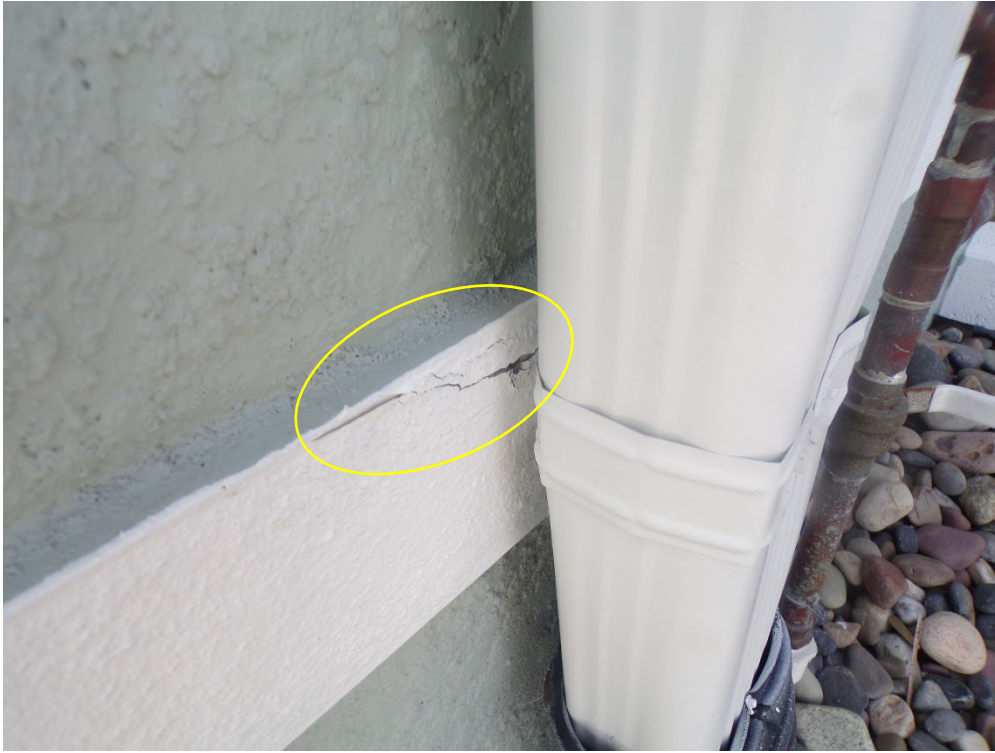
View of typical stucco damage observed.

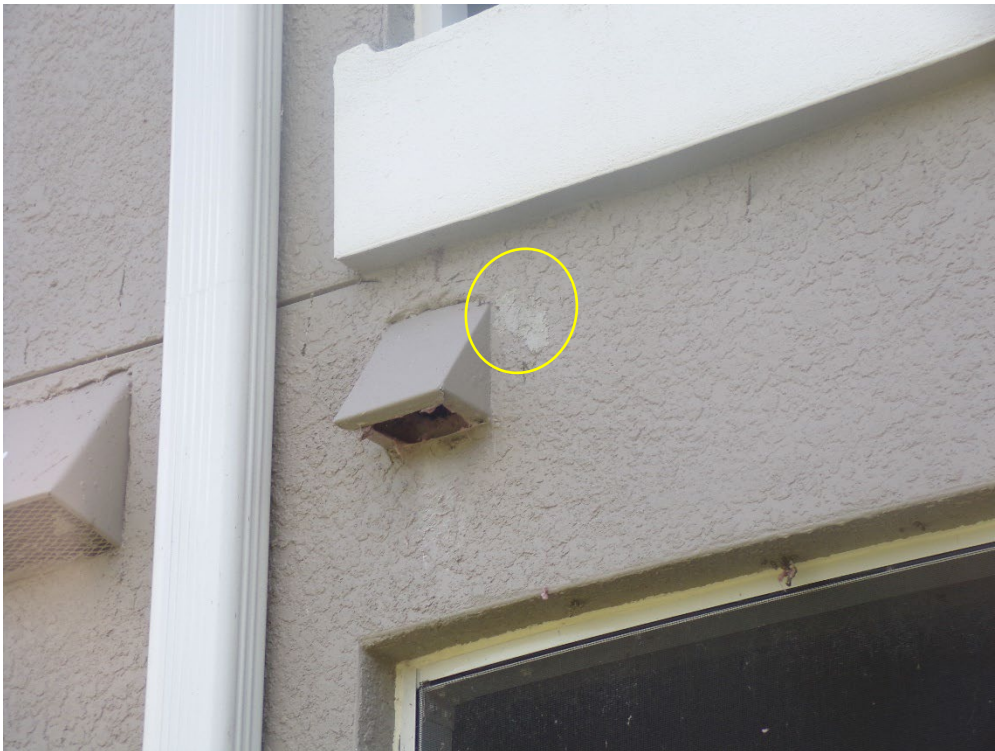
View of typical section of unpainted stucco.

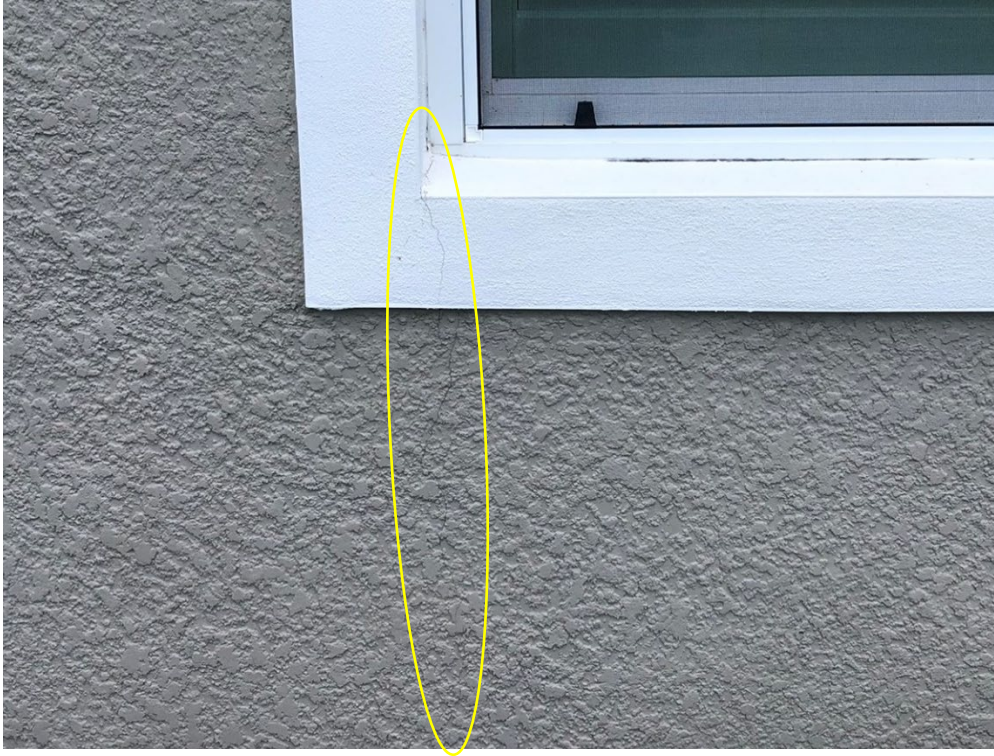
View of typical stucco cracking observed.
