TURNOVER STUDY REPORT

Richmond Park Condo II
2295, 2303, 2304 and 2319 Sawyers Hill Road
2280 and 2281 Priory Lane
Naples, Collier County, Florida
Velocity Project Number: 21-446

Date: Revised July 7, 2022

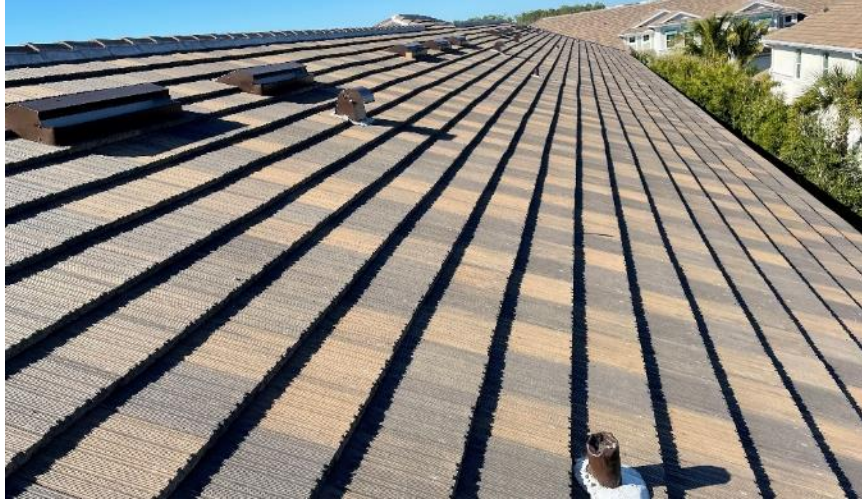
The condominium roofing consists of concrete tile with a self-adhered underlayment. The roof systems were constructed in approximately 2020 and 2021 and appear to be in good overall condition, consistent with their age.

Photograph 1: Overall roof condition

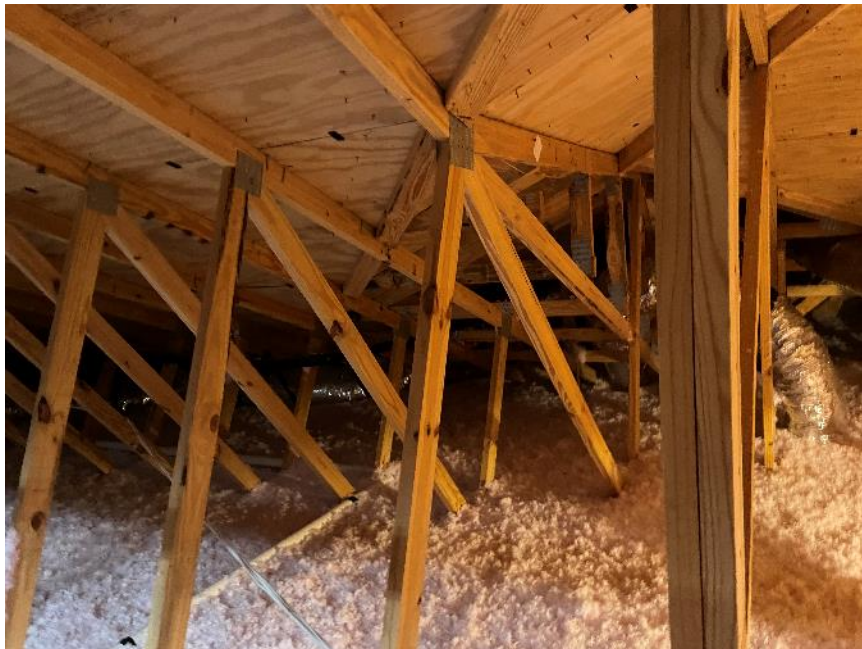
Photograph 2: Attic at 2280 Priory Lane, Unit 1107

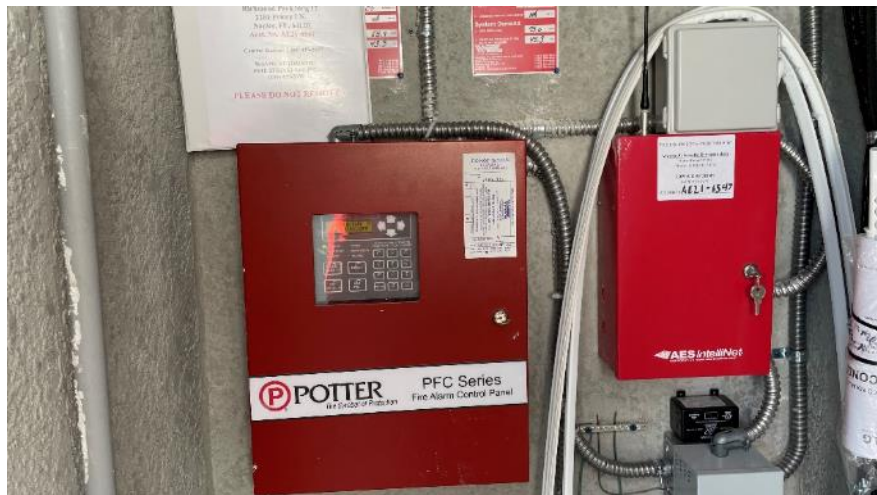
There is fire alarm system equipment located on the side of the condominium buildings addressed as 2319, 2303, and 2304 Sawyers Hill Road. The fire alarm system equipment at 2295 Sawyers Hill Road and 2280 and 2281 Priory Lane is located in an air-conditioned room located within the "Service Court" of each condominium building. The fire alarm system consists of a Potter PFC Series Fire Alarm Control Panel (FACP) and an AES Intellinet communicator. Current inspections tags and reports were observed inside the FACP.

Photograph 3: Fire Alarm Control Panel located within air-conditioned space

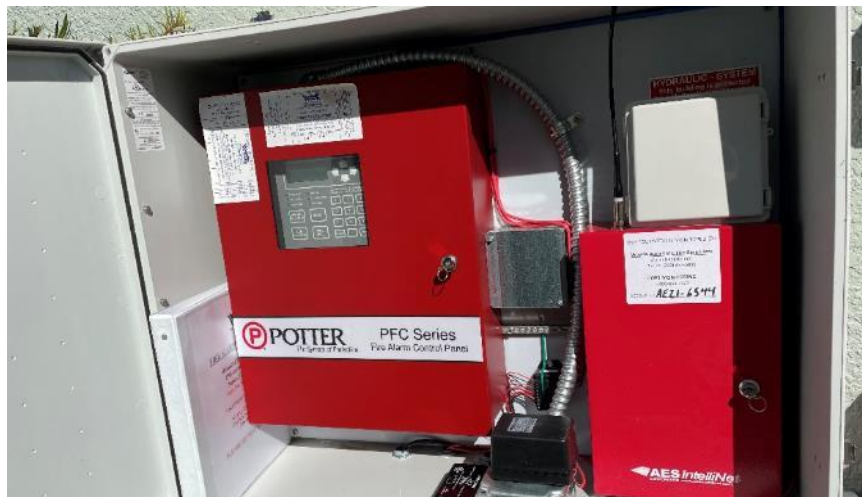
Photograph 4: Fire Alarm Control Panel located on side of condominium building

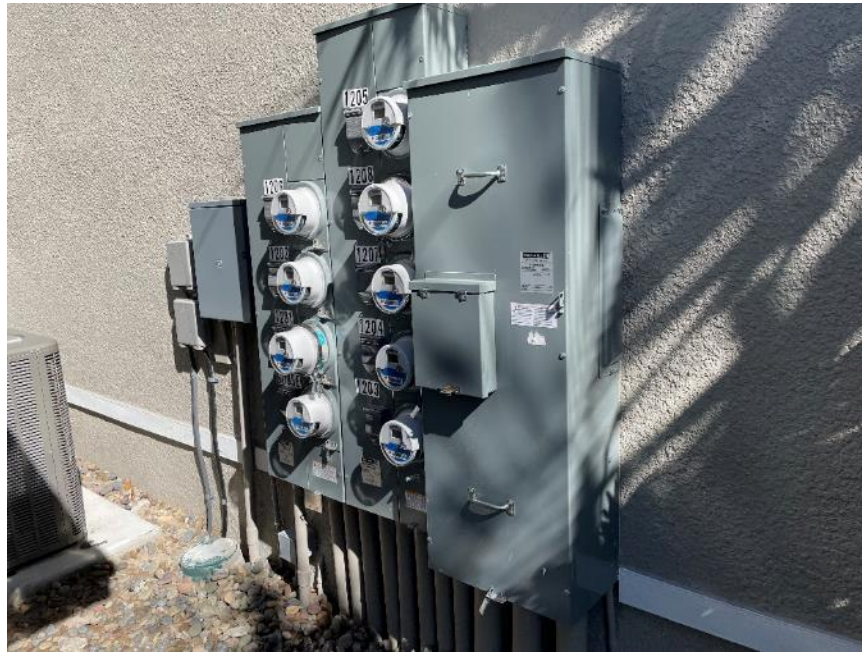
The electrical systems consist of a main panel for each building with an electric meter for each individual unit. The electrical system appeared to be functioning properly at the time of Velocity's inspection. The electrical systems are considered to have an indefinite useful life.

Photograph 6: Main electrical panel and meter bank at 2281 Priory Lane
